Accident 19th November 2013 – Lessons Learned

**Subject:  
Accident  
19th November 2013**

**Total Refinery Antwerp, Belgium**

**Date:  
April 1, 2014**

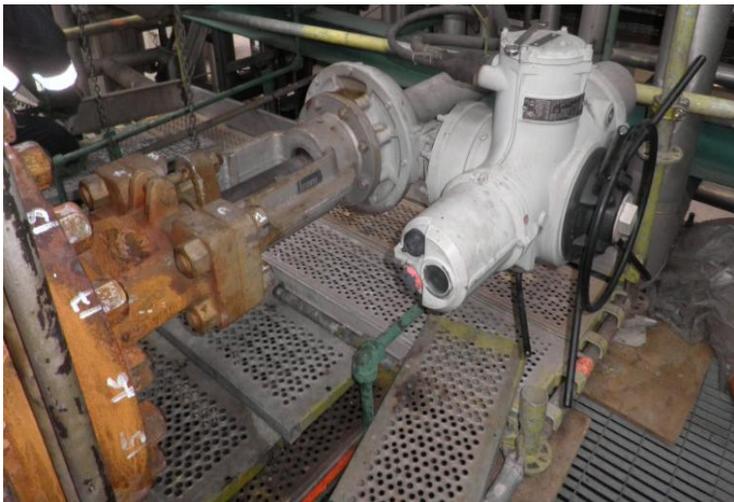
*Identical bonnet – motor configuration*

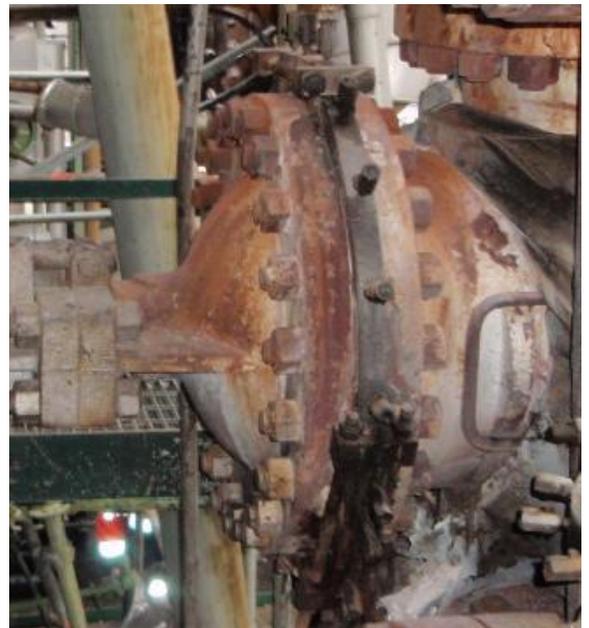
*Identical bonnet – body clamp around adjacent valve*

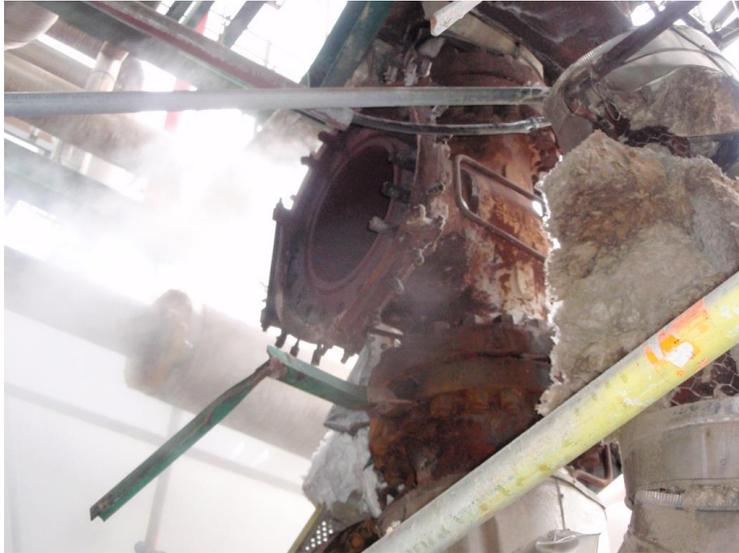
*Valve after bonnet separated*

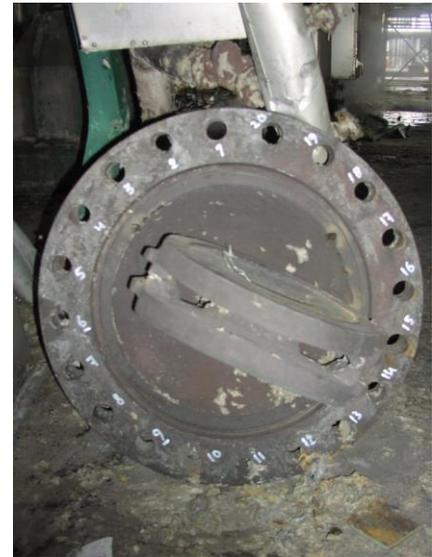
*Separated bonnet*

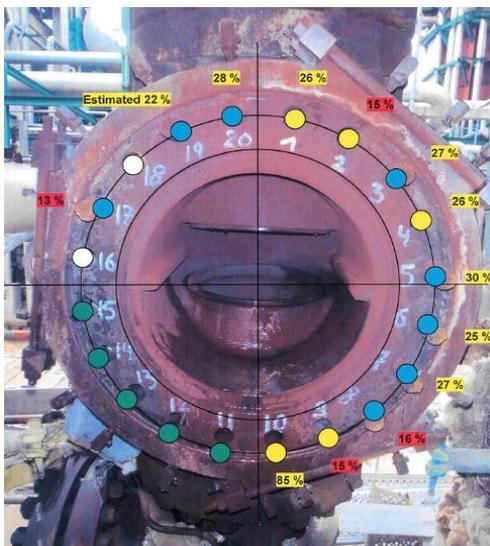
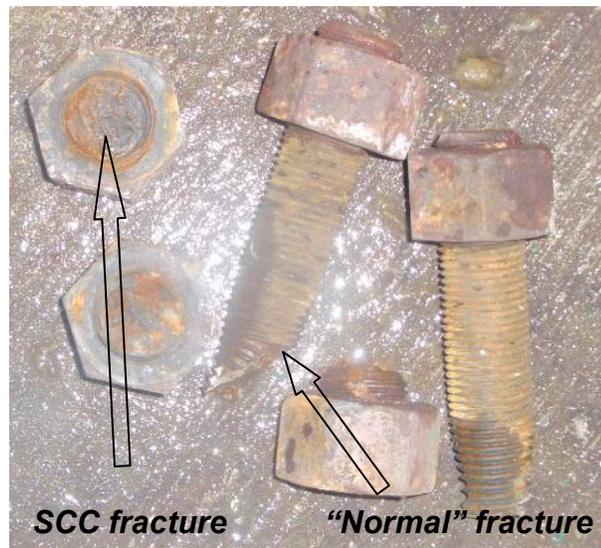
The cause of the bonnet separation was the sudden failure of the stud bolts securing the bonnet. 14 Out of the 20 stud bolts were severely degraded due to (caustic) Stress Corrosion Cracking (SCC) (see also page 5). After examination, the stud bolts showed degradation percentages between 70% and 87%. 6 Stud bolts (no. 11 thru 16) had no signs of SCC and showed “normal” fracture. The bolt failure occurred during the re-injection process through one injection port (between studno.1 & no.2).

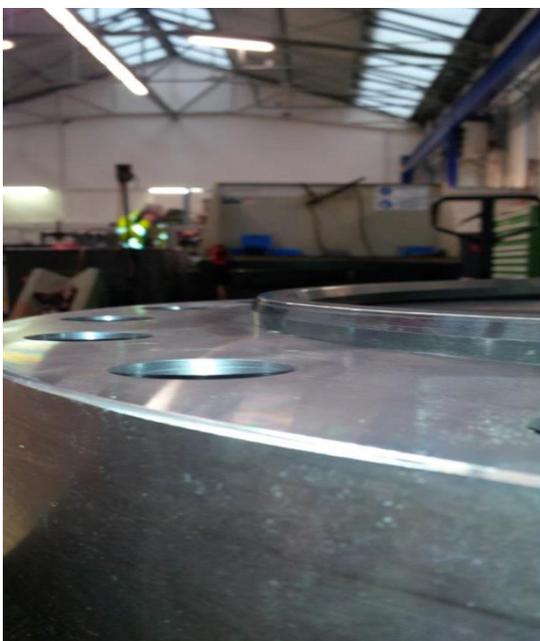
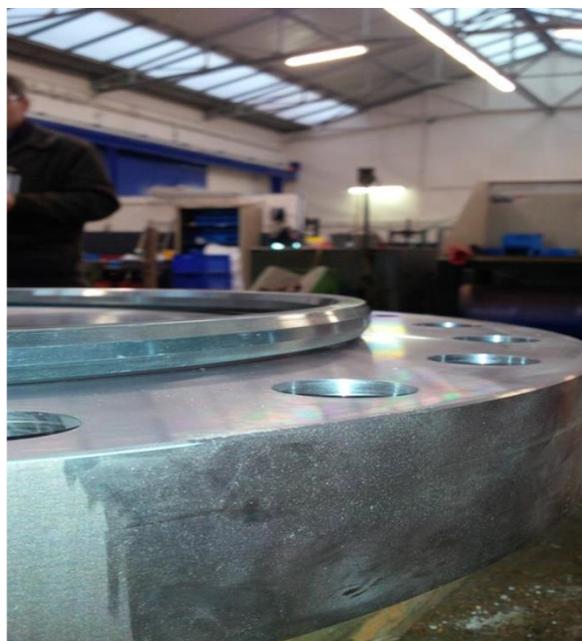
1. The valve has an original design or construction flaw. The diameter of the RTJ groove in the bonnet is 5 mm. too small (acceptable ASME tolerance is 0,13 mm). Because of this design or construction flaw, the standard RTJ ring does not fit in the groove as required. This flaw was not known.

*RTJ ring in an exact copy of the bonnet flange. On the right photo the RTJ ring is out of the groove. On the left photo the ring is in the groove.*

2. This design- or construction flaw resulted in a non-parallel bonnet – body flange connection (with standard assembly of the bonnet and stud bolt stress ( $310 \text{ N/mm}^2$ )). In order to create parallel flanges, several stud bolts have to be tightened with stresses close to the minimum yield. Laser measurements established that the original bonnet flange has taken on the shape of an umbrella. This is another indicator of the high forces in the stud bolts.

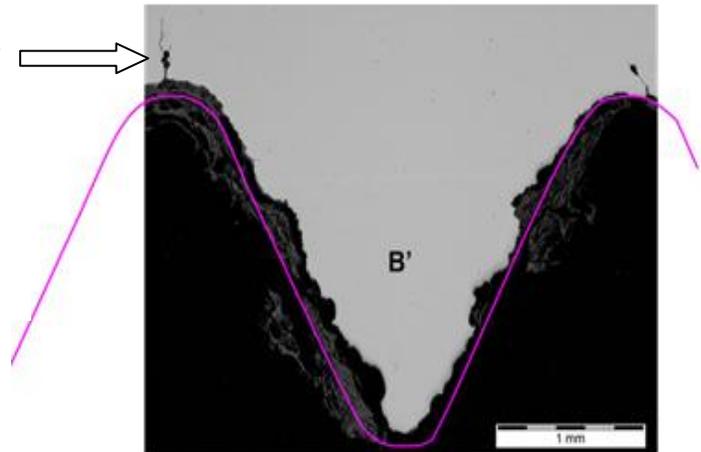
5. After installation of the clamp, the line was out of service for 5 months between April and November 2011 and again in 2012 for about 6 weeks. Once during this period a visible leak occurred and 1 re-injection was performed. The valve remained under pressure, but at low temperatures (dead end). In this cold condition, a minor leak re-occurred inside the flange – clamp assembly creating a wet corrosive environment in which several stud bolts were subjected to general corrosion. Because of this corrosion, the pressure layer (rolled stud bolts) on the outside of the thread that creates resistance against SCC corroded away.

Possibly there were also initial micro cracks present due to galling (hardness of nut and stud bolt are almost the same) when the bolts were tightened.

SCC crack at bottom of the screw thread →

General corrosion affected screw thread of the stud bolts. Light grey is the stud bolt. Purple line is the shape of thread acc. to the standard.

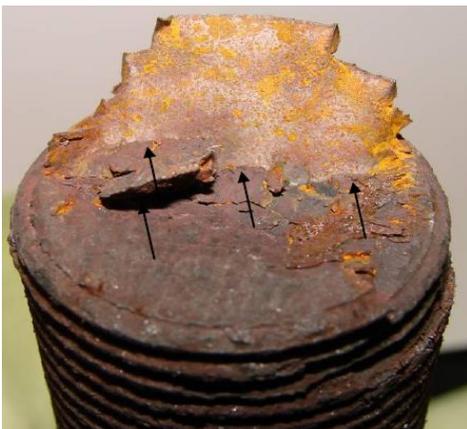
6. After the line came back into service at the end of 2011 the connection leaked several times and injections were performed. During this period an accelerated SCC process started affecting the stud bolts. The boiler water that has leaked evaporates leaving a corrosive residue behind on the degraded stud bolts..

Stud bolt with “old” SCC crack and rest fracture

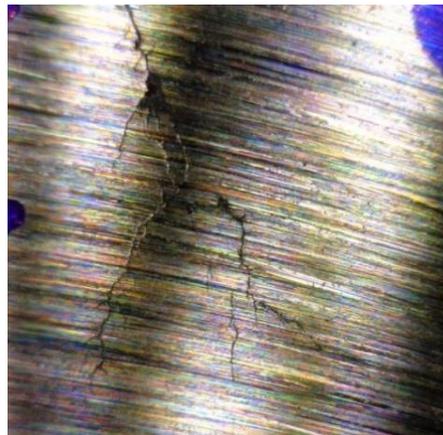
SCC crack under a microscope

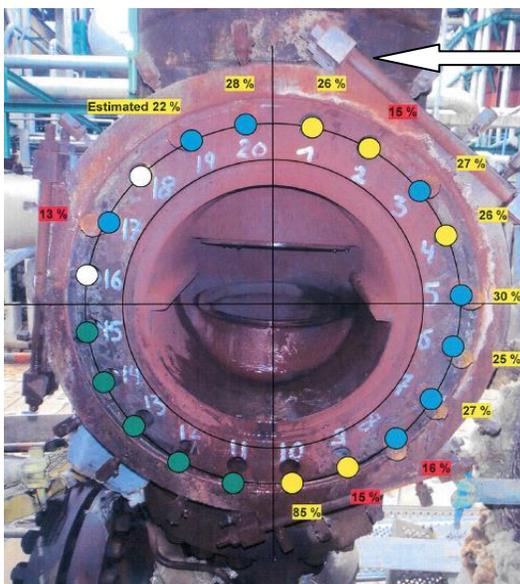
7. On 19th November 2013, the technicians are performing a re-injection on the bonnet – valve body connection with the severely degraded stud bolts. The additional stress on the severely degraded stud bolts occurring during the re-injection process is enough to let one (or more) stud bolts fail. The Fracture of one (or more) bolt results creates an increase in stress on the weakened surrounding bolts, leading to overload and fracture, resulting in a chain reaction and separation of the bonnet from the valve body causing the explosion.

*Location of the re-injection at the position of the weakened stud bolts. The missing injection valve was found connected to the injection pump hose.*

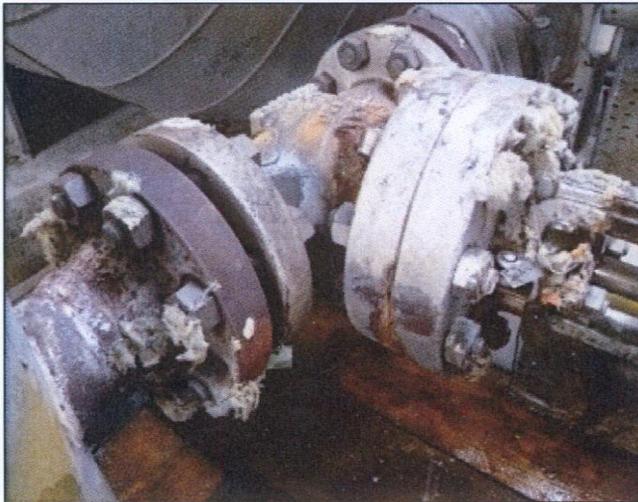
FIG 1

- Visual inspection is not conclusive regarding the condition of stud bolts or other relevant parts.
- SCC can progress very fast. Stud bolts that are in good condition can, under the right circumstances, degrade rapidly due to SCC.
- In case of a re-injection, as part of the risk evaluation, the condition of the stud bolts should be evaluated. The additional forces on stud bolts due to (re) injections do not cause a problem when the stud bolts are in good condition and have a normal stress. Attention is required when the condition of the stud bolts and stress is unknown. Additional attention is also required when there are re-occurring leaks. When boiler water evaporates, caustic residue can stay behind on the stud bolts.
- Extra attention is required when there are white deposits visible on bolts and /or flanges.
