Accident 19th November 2013 – Lessons Learned

**Subject:  
Accident  
19th November 2013**

**Total Refinery Antwerp, Belgium**

**Date:  
April 1, 2014**

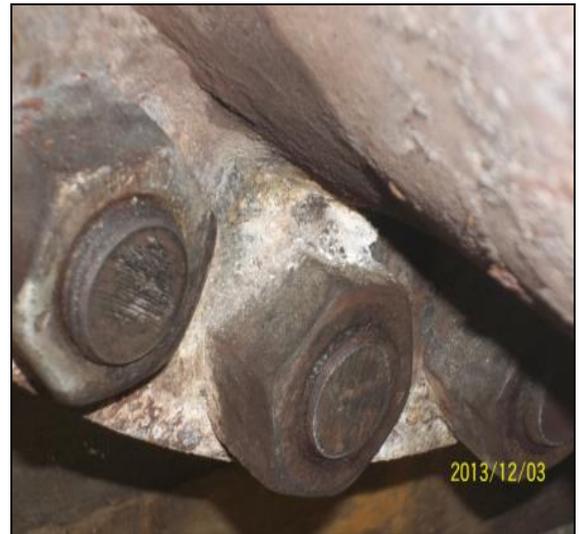
FIG 1

- Visual inspection is not conclusive regarding the condition of stud bolts or other relevant parts.
- SCC can progress very fast. Stud bolts that are in good condition can, under the right circumstances, degrade rapidly due to SCC.
- In case of a re-injection, as part of the risk evaluation, the condition of the stud bolts should be evaluated. The additional forces on stud bolts due to (re) injections do not cause a problem when the stud bolts are in good condition and have a normal stress. Attention is required when the condition of the stud bolts and stress is unknown. Additional attention is also required when there are re-occurring leaks. When boiler water evaporates, caustic residue can stay behind on the stud bolts.
- Extra attention is required when there are white deposits visible on bolts and /or flanges.
